# Manhole Inspection Summary

Manhole # S41W1\_020MH

Insp Date: **12/4/07 10:41 AM**

**Location** Address: **526 Arsan Ave**

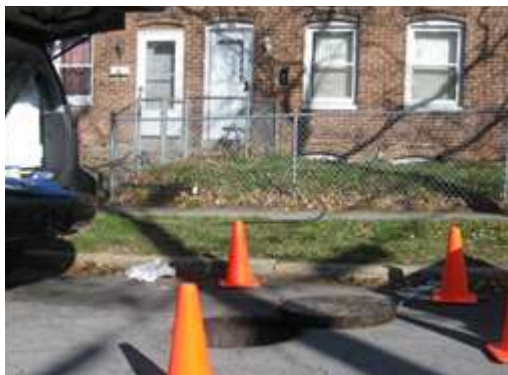
Location View

Arsan Ave.

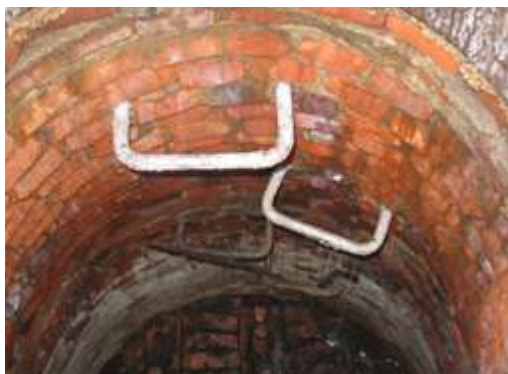
Steps

**Steps** Count: **4** Missing: **0** ☐ Corroded

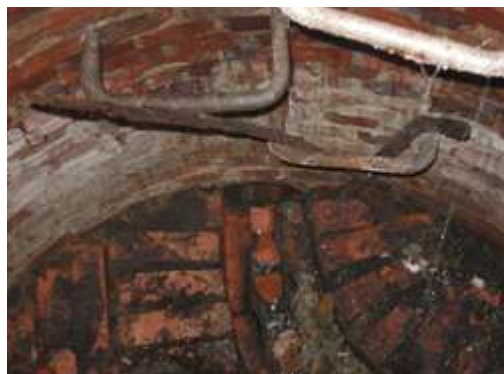
Defect 1

Pole in steps

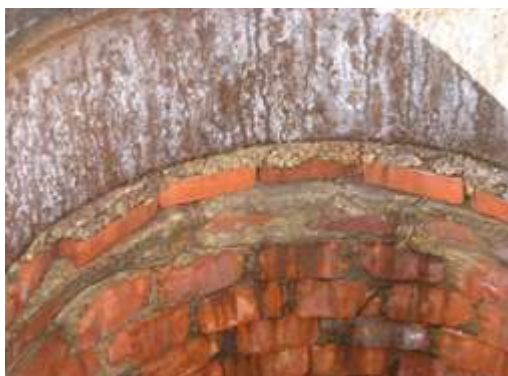
Defect 2

Infiltration: ☐ None ☐ Joint ☐ Cracks ☒ **Mortar** ☐ Roots ☐ Wall

Mortar

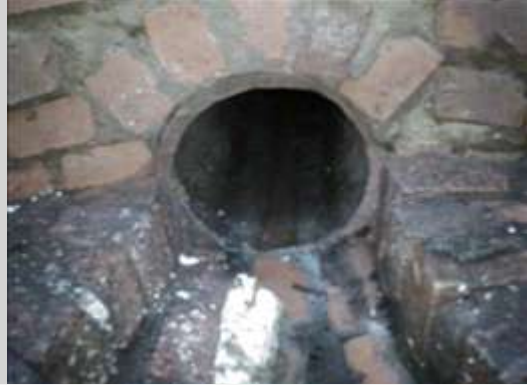
12 O'Clock Outflow

8 in. Circular Gravity Sewer  
Pipe Out @ 12 O'Clock

Infiltration: **None** Pipe Seal Cond: **Sound**

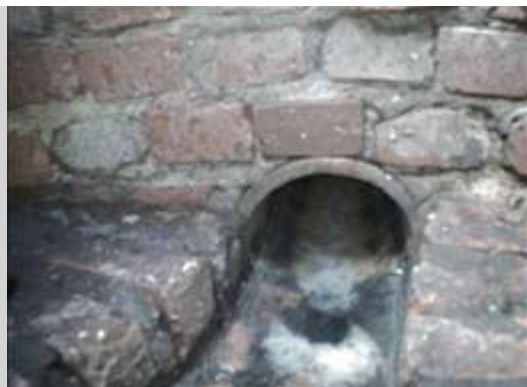
3 O'Clock Inflow

6 in. Circular Service Sewer  
Pipe In @ 3 O'Clock

Deposits: ☐ None ☐ Mud ☐ Sludge ☒ **Debris** ☐ Grease

Silt Depth: **2** (in.) Deposits Extent: **Light**

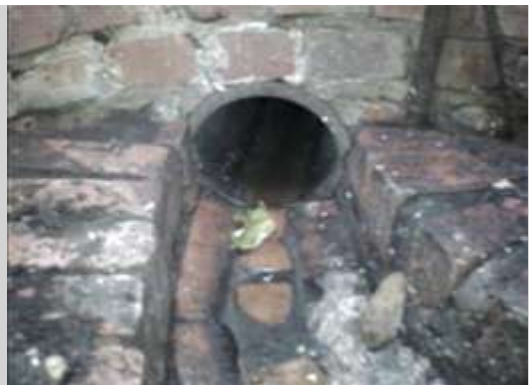
9 O'Clock Inflow

6 in. Circular Service Sewer  
Pipe In @ 9 O'Clock

Infiltration: **None**
